DEPARTMENT OF TRANSPORTATION

Quality Assurance and Source Inspection

Contract #: 04-0120F4Cty: SF/ALA Rte: 80 PM: 13.2/13.9File #: 69.28**WELDING INSPECTION REPORT****Resident Engineer:**Siegenthaler, Peter**Address:** 333 Burma Road**City:** Oakland, CA 94607**Report No:** WIR-021031**Date Inspected:** 27-Feb-2011**Project Name:** SAS Superstructure**OSM Arrival Time:** 700**Prime Contractor:** American Bridge/Fluor Enterprises, a JV**OSM Departure Time:** 1900**Contractor:** Zhenhua Port Machinery Company, Ltd (ZPMC), Changxing Island **Location:** Shanghai, China**CWI Name:** Zhou Zhong Hai**CWI Present:** Yes No**Inspected CWI report:** Yes No N/A**Rod Oven in Use:** Yes No N/A**Electrode to specification:** Yes No N/A**Weld Procedures Followed:** Yes No N/A**Qualified Welders:** Yes No N/A**Verified Joint Fit-up:** Yes No N/A**Approved Drawings:** Yes No N/A**Approved WPS:** Yes No N/A**Delayed / Cancelled:** Yes No N/A**Bridge No:** 34-0006**Component:** OBG COMPONENT**Summary of Items Observed:**

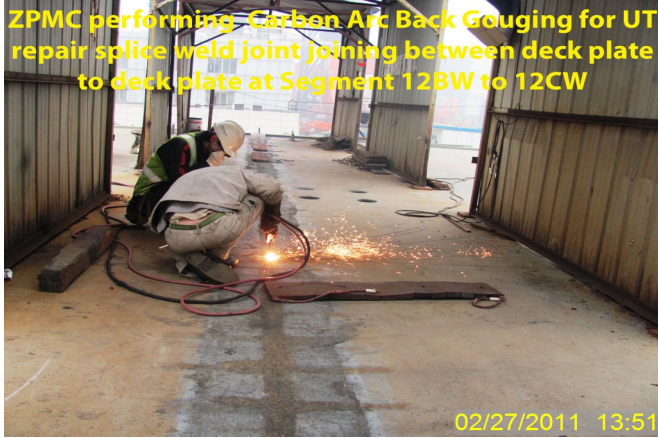
02/27/2011 13:51

ZPMC performing Carbon Arc Back Gouging for UT repair splice weld joint joining between deck plate to deck plate at Segment 12BW to 12CW

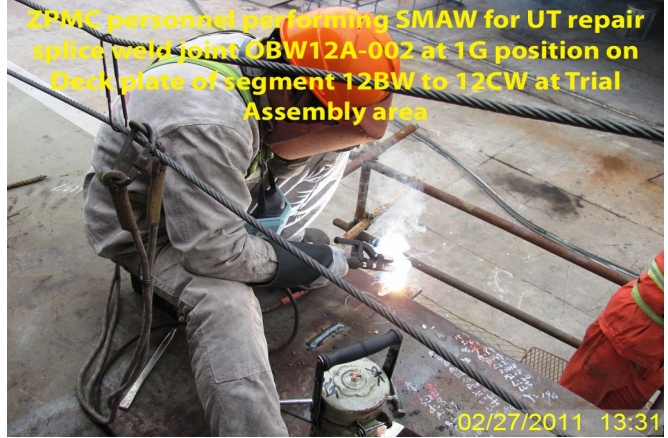
02/27/2011 13:31

SMAW in the 1G position for the OBG Segment 12BW to 12CW ,UT repair weld No. OBW12A-002. The welder is identified as #040611. ZPMC QC is identified as Mr.Zhou Zhong Hai. The welding variables recorded by QC appear to comply with WPS-345-SMAW-1G(1F)-REPAIR-FCM-1.The weld repair report is identified as WR20315. The welding variables were recorded at, Amperage 176, volts 23.4.The In-process SMAW appears to be progressing in compliance with approved contract documents.

ZPMC personnel performing SMAW for UT repair splice weld joint OBW12A-002 at 1G position on Deck plate of segment 12BW to 12CW at Trial Assembly area
